# Homebrew 2021

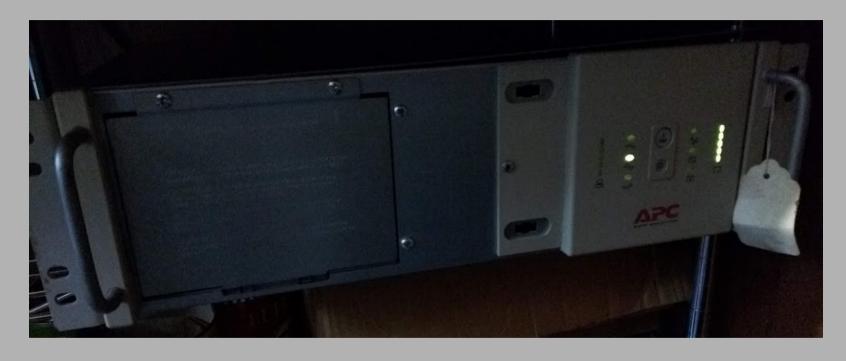
#### New batteries + cable fixed old UPS (success)

The old tag said "non-op", but Sam WB6RJH found that it still worked.

4 new 7Ah batteries, battery cable with large PowerPole, rear enable socket defeated.

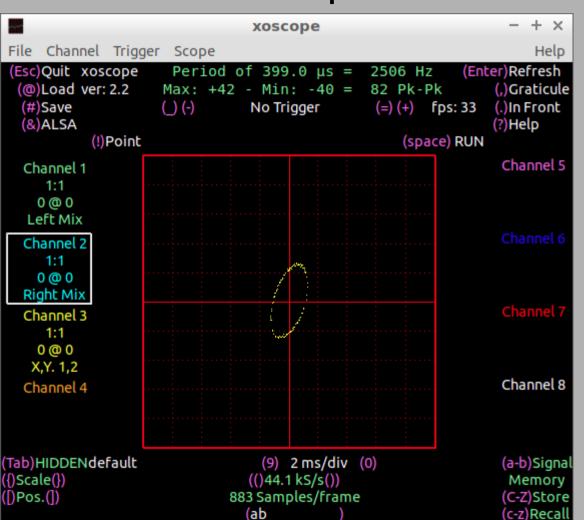
## Added X/Y plot mode to xoscope (success)

xoscope is a sophisticated "software oscilloscope" linux. The primary limit is the soundcard, in my case Creative X-fi USB dongle.

X/Y plot mode used to be implemented in a separate program, which had been abandoned.

My simple add-on math function is good enough, although it cannot display more than one Y value at each X value.

Used for zero-beating during FMT.

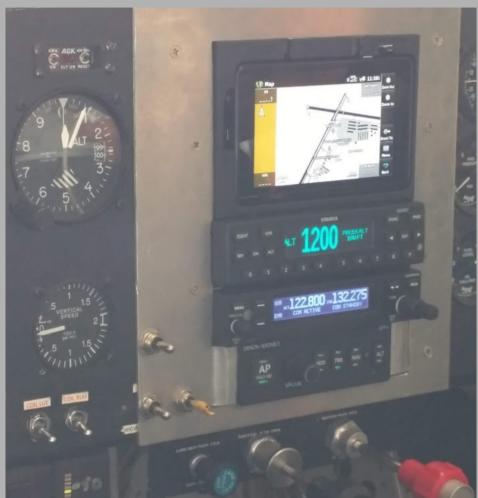
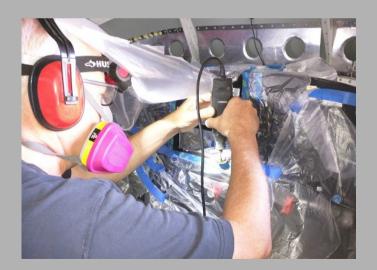
#### ADS-B upgrade

FAA required new transponders with ADS-B capability.

New unit was larger than previous, requiring major surgery to instrument panel.

New sub-panel has standard 6.5" mounting rails.

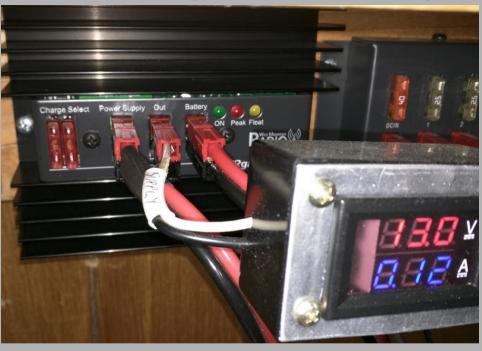
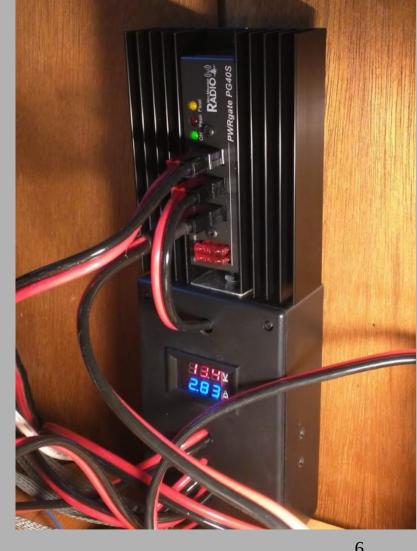
# 12V improvement (success)

Old connections were too long, with too many fuses in series.

2 loose connectors were found during this reorganization!

Volt-Ammeter consolidated with bolted ring terminals for power to transceivers.

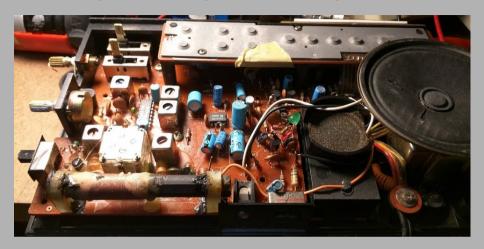
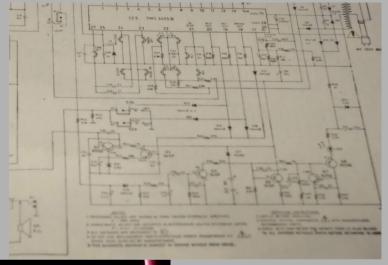
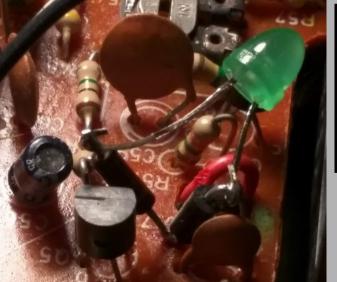
#### super-cap backup for RadioShack clock (partial success)

LED + R charges 2 super-caps in series.

Works OK for 2 seconds, but not for hours.

Larger super-capacitors ???

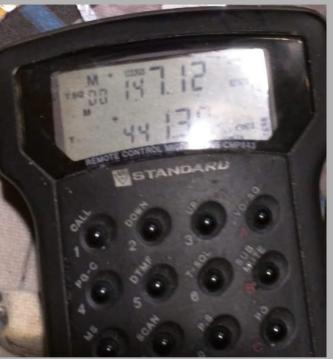
### Standard CMP843 LED backlight (no progress)

"all the controls in the mic" is difficult without the backlight!

Twisting the mic case indicates it is an intermittent connection.

Suspected inter-board connector is not the problem.

\$50 service manual has X-ray views, etc., but does not have complete schematic details of LED power.

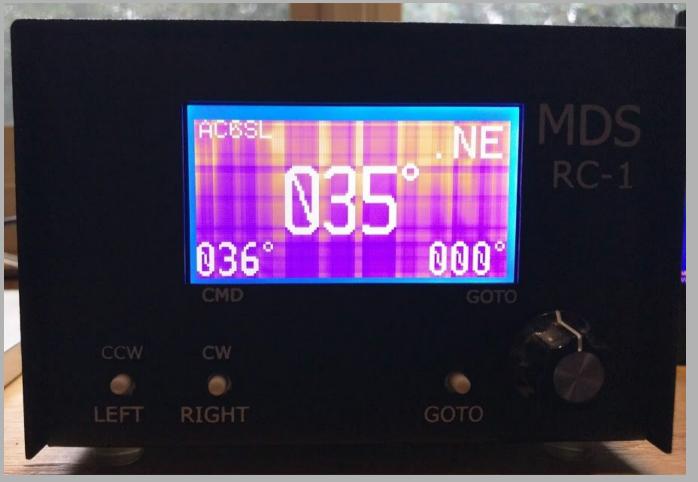
## MDS RC-1 Display contrast (no progress)

Azimuth can be read & set from computer, but the display is needed to access the setup menus.

Display contrast goes through wild swings, just from hand capacitance near the case.

Case cover cannot be removed without disconnecting power, which changes the symptoms.

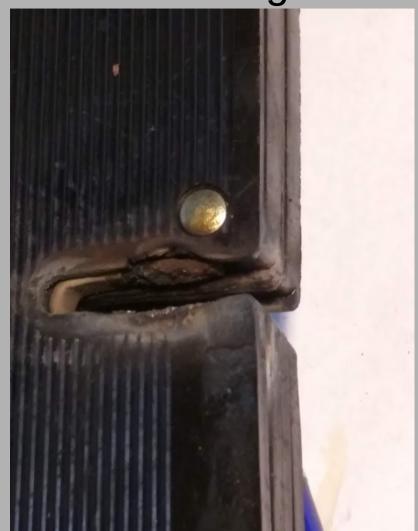
# Oven heating coil not working (partial success)

Zinsco circuit breakers were designed during a shortage of Copper, so they started using Aluminum.

6061 alloy is not a good choice for electrical work, because the coefficient of thermal expansion is large, i.e. connections shrink open when cold.

Oven is working again, but service panel, subpanel, & all the breakers need replacement.
